Seagull Intersection Layout. Island Point Road - A Case Study

John Harper, Wal Smart, Michael de Roos

Roads and Traffic Authority of New South Wales

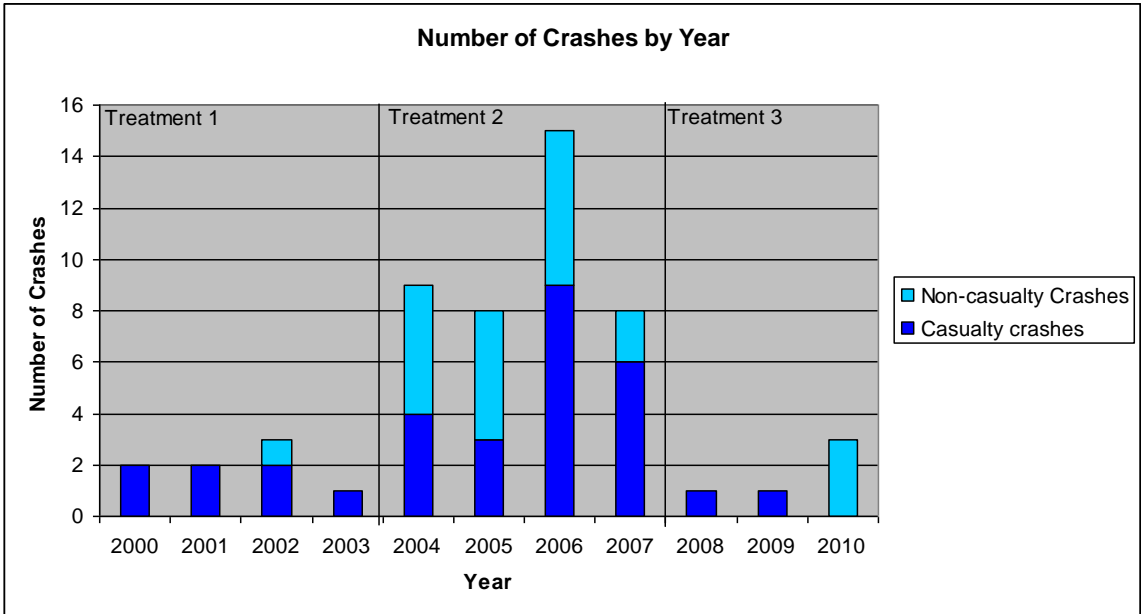
Graph 1: Crashes Vs Treatment Type

As can be seen from this graph there was a significant rise in the crash rate following the construction of Treatment 2, which continued until the construction of Treatment 3 in mid 2007. Construction of Treatment 3 which is currently in place has resulted in a significant improvement in the crash rate. The graph also shows the number of casualty crashes for each year with 9 casualty crashes in 2006. Of the total of 53 crashes, 31 were casualty crashes resulting in 57 injuries and 2 fatalities. The majority of the casualty crashes (22) and injuries (37) and 1 fatality occurred while treatment 2 was in operation.

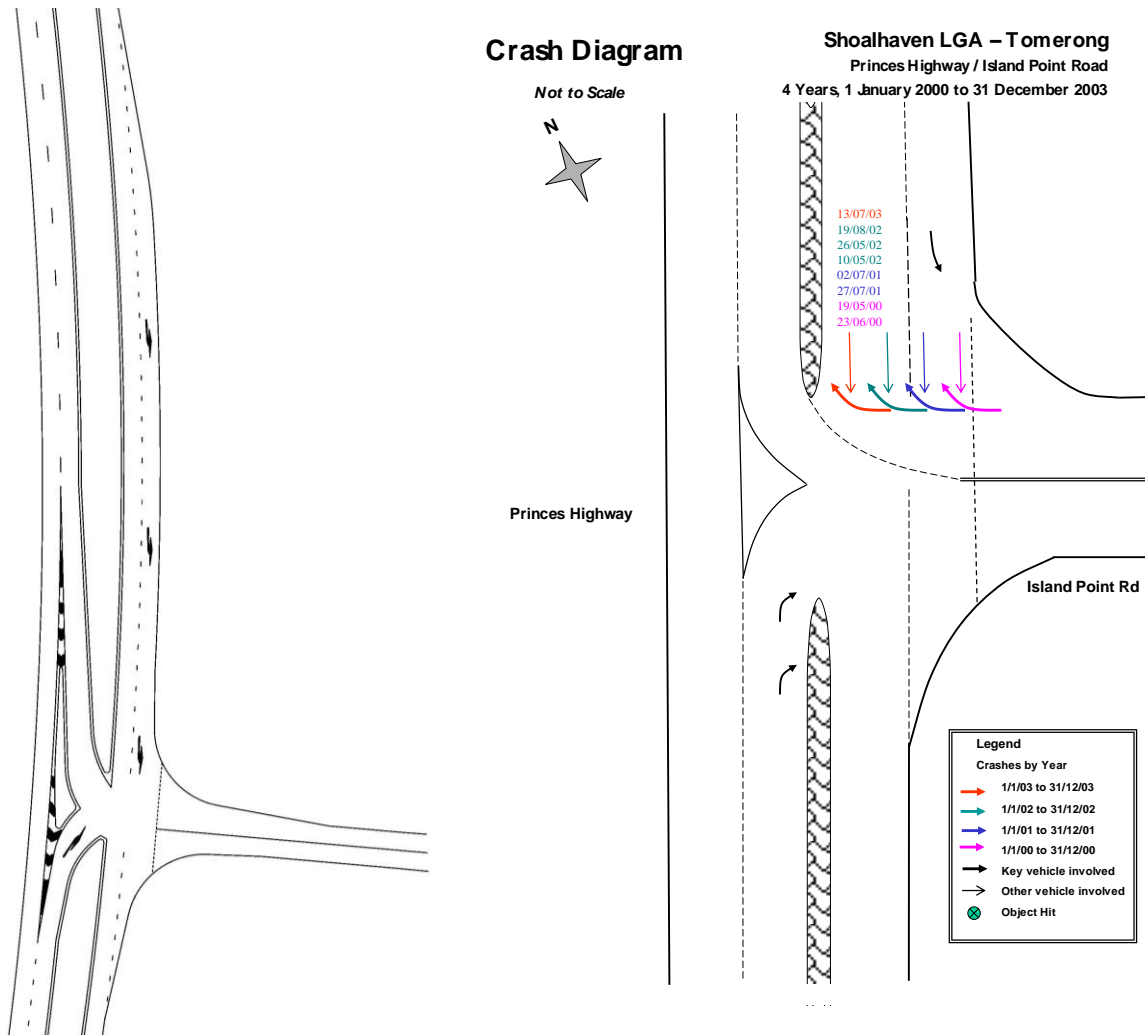
Figure 1: Treatment 1 Design Layout

The layout depicted in Figure 1 was constructed as part of a larger upgrade of the Princes Highway in this area to improve highway alignment and separate opposing traffic. The layout was designed in accordance with the standard rural seagull design layout. Following the installation of Treatment 1 a 'right near' crash type started to develop as shown in Figure 1.1. The colours in Figure 1.1 represent the different years and the date of each crash is shown. Treatment 2 was then designed and constructed in an attempt to address the 'right near' crashes.

The first seagull layout (Fig. 1), was constructed in accordance with the standard seagull design layout in 1996 but developed a poor crash history with vehicles turning right out of Island Point Road colliding with through southbound vehicles approaching on their right.

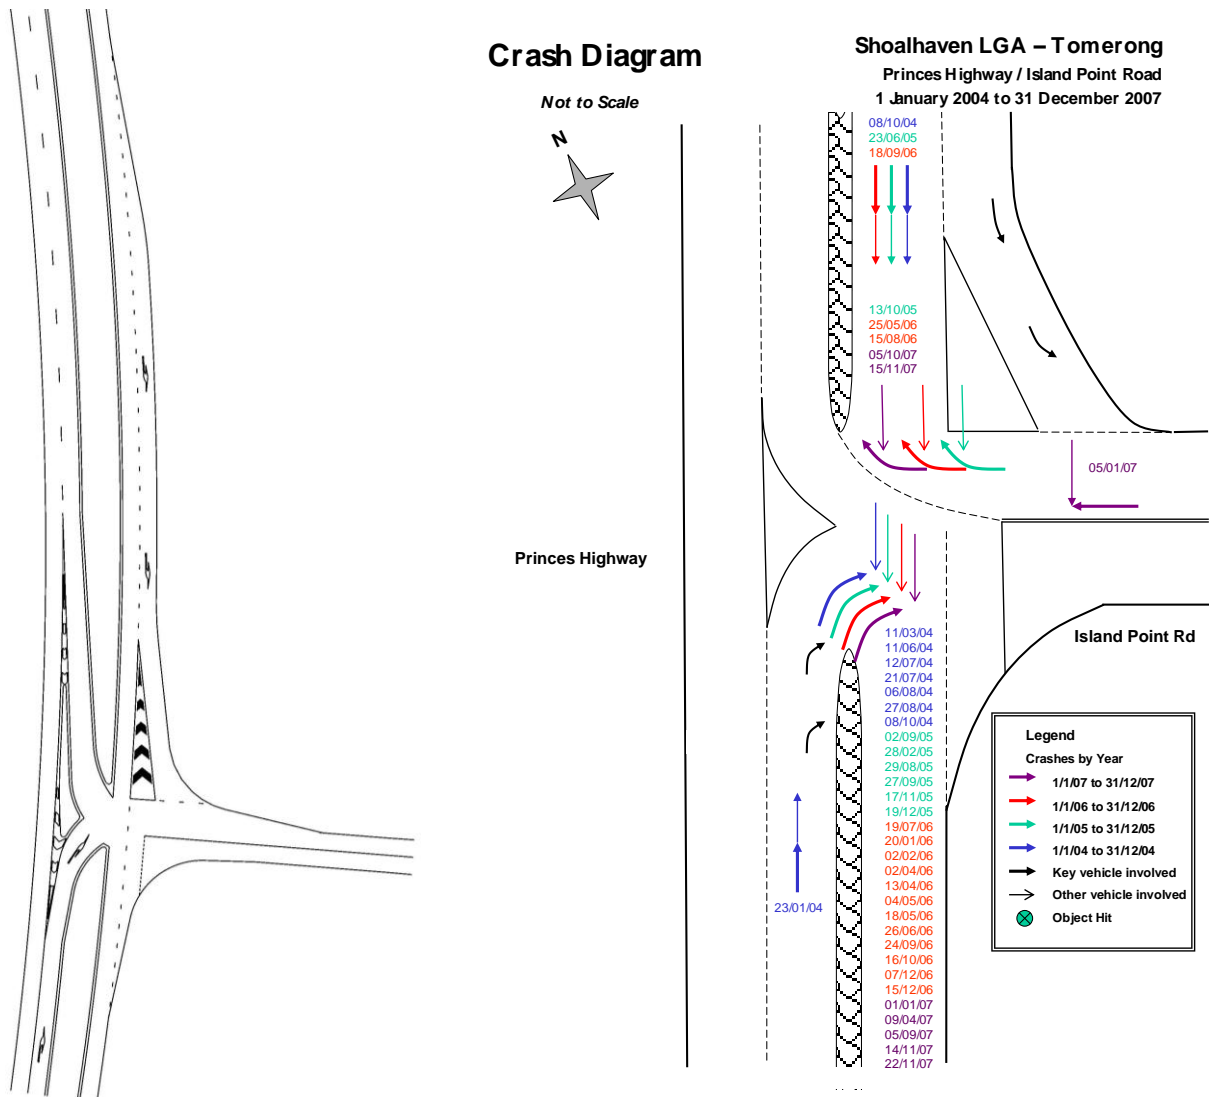
Figure 2: Treatment 2 - Design Layout

Treatment 2 involved the modification of the original seagull layout with the inclusion of a short left turn splay, which included a small raised concrete island, at the southern end of the painted chevron area. The layout also included the installation of a hold line and give way sign at the left turn deceleration lane's junction with Island Point Road. However the crash data in Figure 2.1 shows the development of a very significant number of 'right through' crashes yet previously there were no crashes of this type. In addition there has been no impact on the 'right out with through southbound' crash type that this layout was intended to address.

In an attempt to address the crash types that had developed, a relatively minor adjustment was made to the layout (see Fig. 2). This involved the construction of a short left turn splay at the southern end of the left turn deceleration lane near its junction with Island Point Road. It also included the installation of a small concrete island, a hold line and give way sign at the left turn lane's junction with Island Point Road as depicted in Figure 2.

The construction of Treatment 2 did not address the 'right through' type crashes but it was also accompanied by a new and significant crash problem involving vehicles turning right into Island Point Road colliding with through southbound vehicles. There were no crashes of this type prior to the reconfiguration of the left turn arrangement which was in accordance with *Part 4A Austroads Fig 7.14*. It was not immediately obvious why this crash type developed. Drivers turning right into Island Point Road were now appearing to make poor decisions when turning right in front of opposing southbound through traffic. It is of interest that the only adjustment to the layout that coincided with the occurrence of these crash types was a minor modification of the left turn lane and the inclusion of a give way sign for southbound left turning traffic.

It was found that traffic turning left off the highway into Island Point Road were stopping at the hold line to give way to those vehicles stored waiting to turn right into Island Point Road off the highway. This was confusing to some drivers waiting to turn right off the highway as it is counterintuitive to the standard give way rules that normally apply at a 'T Junction'. It appears that right turning drivers would be more focused on vehicles in the left lane to anticipate if they would yield right of way, rather than focusing on the opposing through vehicles. On site observations also revealed that in other cases drivers waiting in the left turn lane would actually call right turning drivers through the junction. The drivers of these vehicles were only 8 metres apart.

The design of Treatment 2 with the left turn splay arrangement and the inclusion of a 'Give Way' sign at its junction with Island Point Road appear to have put doubt in the minds of drivers, as it was counterintuitive to the Give Way rule applying at 'T Junctions'. Based on the on-site observations of driver behaviour and the more in depth investigations of Police crash reports, it was evident that the confusion between drivers making these turns has contributed significantly to the 'right through' crash type. There were also many accounts of near misses associated with this scenario.

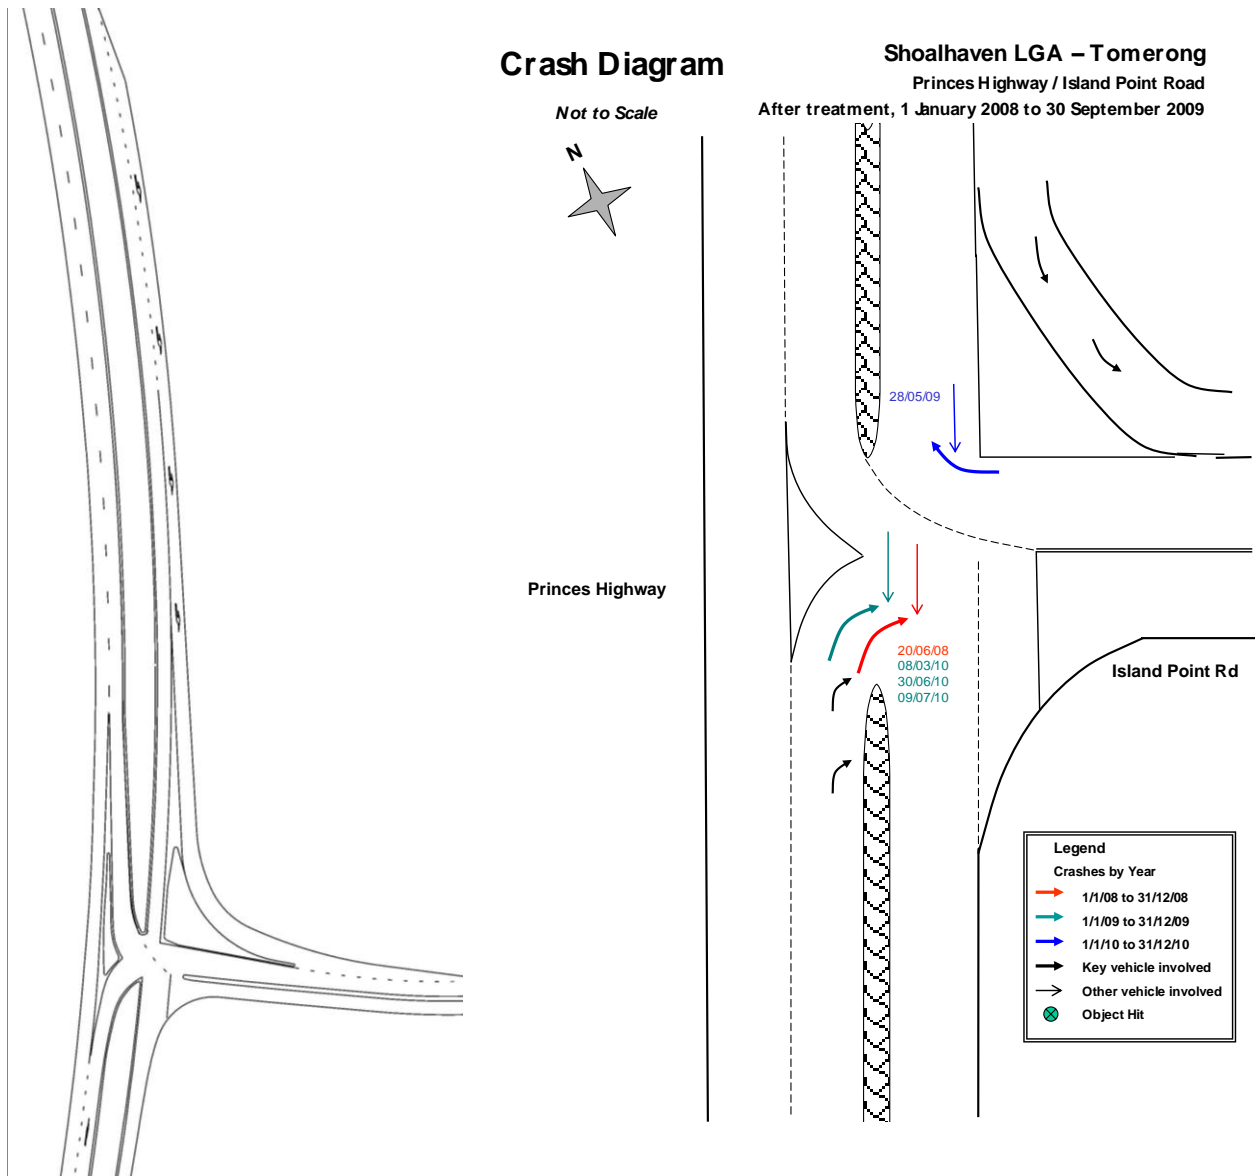
Figure 3: Treatment 3 - Design Layout

A third modification of the seagull treatment included two key features. The first was to move the junction of the left turn lane with Island Point Road further east from the Princes Highway and provide a merge of the left turn deceleration lane with Island Point Road. The second was a major widening at the throat of the junction to further separate the left turn deceleration lane from the southbound through lane which significantly opens up available sight distance to the north for vehicles exiting Island Point Road. As can be seen from Figure 3.1 this third modification also coincided with a significant reduction in the number of crashes, especially the ‘right thru’ crash type.

Following identification of the contributing factors associated with the 'right through' crashes, Treatment 3 (see Fig.3) was developed. In developing this treatment careful consideration was given to address not only this crash type but also the 'right out with through southbound' crashes. Any proposed countermeasures needed to be combined into the one treatment.

The first part of the countermeasure was to move the junction of the left turn lane with Island Point Road further away from the Princes Highway. This increased the separation of left turning vehicles from the vehicles waiting to turn right into Island Point Road thus reducing any confusion that may have previously occurred where drivers had eye contact. As part of this work the left turn lane was returned onto Island Point Road where a merge was provided. The need for either driver to yield to the other at the junction was now removed in favour of a merge away from the junction. It also made the decision process for drivers turning right simpler as they now only had to focus on through southbound traffic. This countermeasure focused on addressing the 'right through' crash type.

The second countermeasure was to move the left turning traffic clear of the sight line of vehicles waiting to turn right from Island Point Road. This was done by providing greater separation between the left turn deceleration lane and through southbound vehicles on the Princes Highway. This not only further increased sight distance to the north for vehicles exiting Island Point Road but also reduced the potential for left turning vehicles to 'mask' through southbound vehicles. This countermeasure focused on crashes involving vehicles turning right out colliding with through southbound vehicles on the Princes Highway. This crash type had developed under Treatment 1 and continued under Treatment 2. As can be seen in Figure 3.2 the construction of Treatment 3 has been effective in significantly addressing both crash types.
