GRSP/MOT Speed Management Pilot Project in China

Abstract:

Speeding and inappropriate speed are recognized as major contributory factors in both the number and severity of traffic crashes in most of the countries in the world including China. Working together with the Research Institute of Highway (RIOH) of the Ministry of Transport (MOT), Global Road Safety Partnership (GRSP) carried out a 4-year speed management project in China during 2008-2011.

The project was divided into 2 phases: phase I – speed management situational survey at 6 different road segments in Beijing and Guangxi Province; phase II – implementation and evaluation of speed management Intervention countermeasures at G103 highway in Beijing.

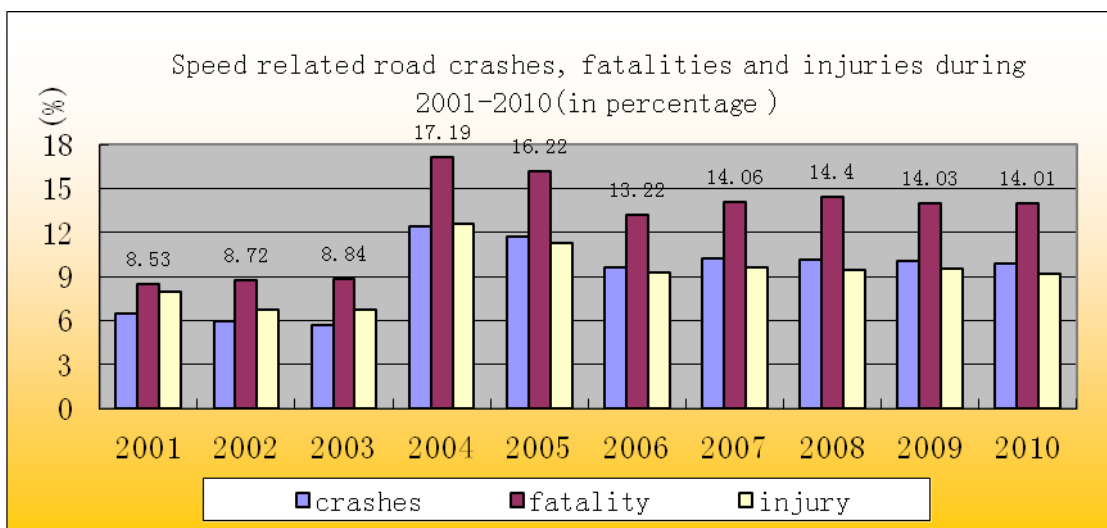
Chart 2 Speed related road crashes, fatalities and injuries during 2001-2010 (in percentage)

number of road crashes reached a peak in 2004, speed related fatalities were up to 18,000 during the year. By reviewing the crash data of the last 5 years, it was found out that speeding-related crashes and injuries account for 10% in total number of road crashes and related injuries; while for fatal crashes it is around 14%. Speeding-related crashes are more serious in terms of fatality per crash as opposed to other types of crashes - it accounts for about 14% of the total road fatality in 2010, which was the higher than other types of crash [2]. The charts 1 and 2 below show the number and percentage of the speeding related road crashes, fatalities and injuries during 2001-2010 in China. (Data source: annual report for road traffic crashes issued by ministry of public security, China)

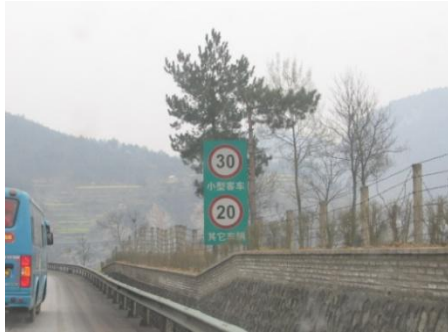
Figure 1 Too low speed limit on expressway

In China, due to lack of technical standard and operational guidelines, many speed related issues exist. For example, inappropriate speed limits were set up on the roads (either too high or too low). The Figure 1 below shows the posted speed limit on an express highway, which for passenger cars is 30km/h and for other vehicles is 20km/h; while the Figure 2 shows the two different speed limit signs posted at the same road section without any explanation, it is hard to understand if they are setting up for different lane or different type of vehicle.

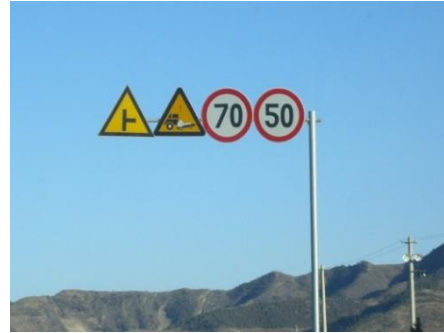
Figure 2 Ambiguous speed limit signs

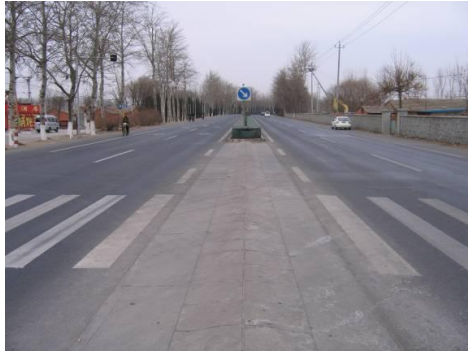
Figure 3 Typical cross-section for K26-30

This road section is located in flat area; the general geometric alignments are preferably good without noticeable sharp curves, steep grades and constricted sight distance. It is a two-way four lanes (part of stretch has six lanes) road; the traffic at opposite direction are physically divided by iron fence, median with vegetation or concrete barriers. The figure 3, 4, 5 and 6 blow show the typical road condition of at different sections of the between K26-50 of the G103 Class I highway. Area along the road has dense populations with many towns or villages. High density of accesses or intersections is a notable characteristic. Main intersections are controlled by signals while small intersection and accesses are controlled by stop/yield signs.

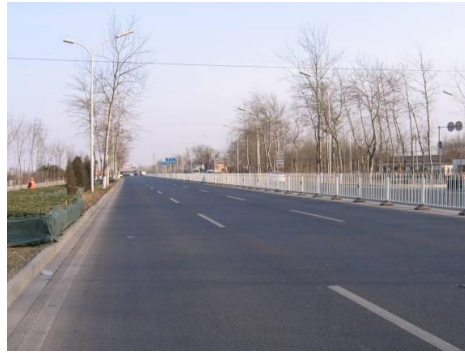
Figure 4 Typical cross-section for K30-39

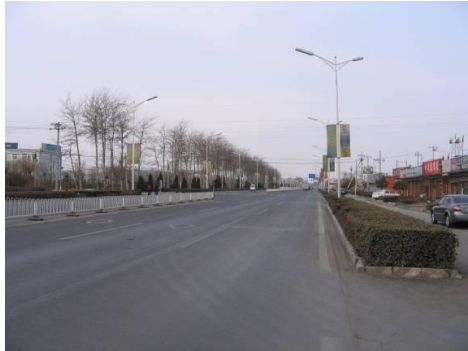
Figure 5 Typical cross-section for K39-41

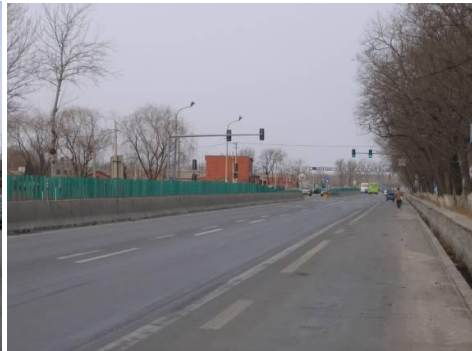
Figure 6 Typical cross-section for K41-50

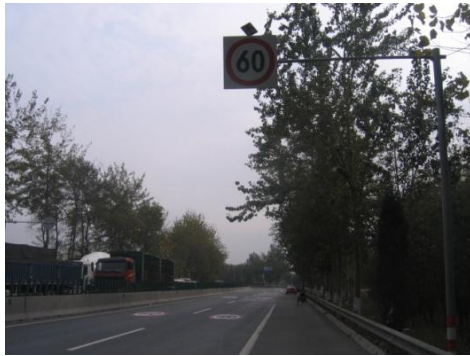
Figure 7 Extension of speed limit sign posts

The problem found at the road sections and speed zones include speeding rate was high; some of the speed limit signs at the speed zone had either poor visibility (obscured by trees or other objects) or not informative enough. The countermeasures taken at the road sections include adjustments of speed limit signs, horizontal speed pavement markings, transverse speed pavement markings,

peripheral speed pavement markings were implemented (as shown of figure 7, 8, 9, 10, 11 below) in order to reduce the travel speed of the drivers.

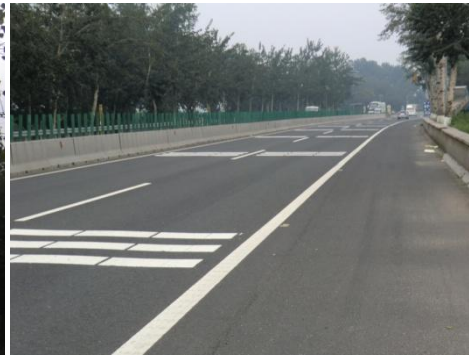
Figure 8 Horizontal Pavement Marking

Table 2 below shows the vehicle speed at before and after different types of speed reduction pavement markings implemented. It shows the transverse pavement marking is most effective and followed by the peripheral pavement marking.

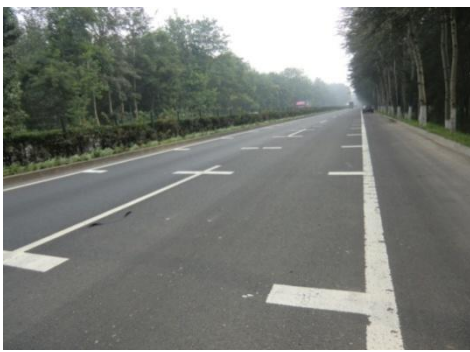
Figure 9 Peripheral Pavement Marking

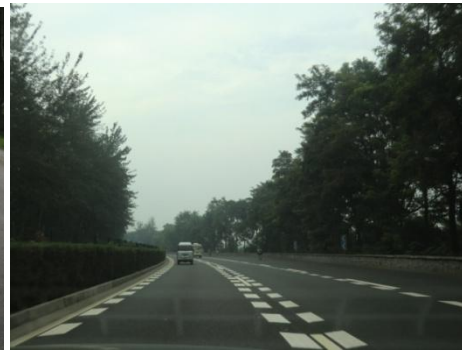
Figure 10 Transverse Pavement Marking

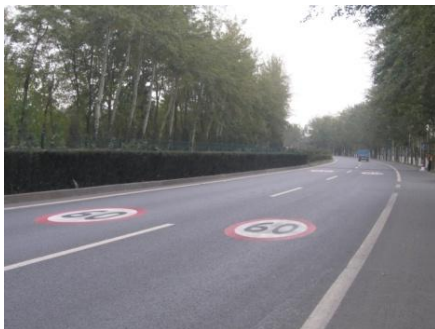
Figure 11 “Gate” at the beginning of the speed zone

A colorful skid resistance pavement was put at one of the speed limit zones as the “gate” with the speed limit (60km/hour) posted on the ground in order to make the speed zones more visible and informative as shown of the figures 11 and 12 below:

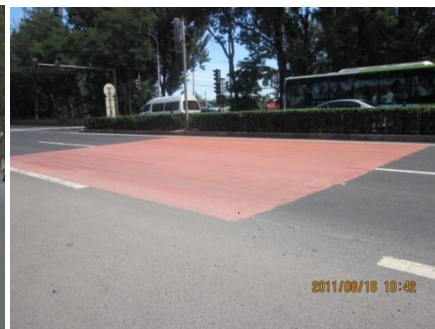
Figure 12 Speed limit sign on the ground

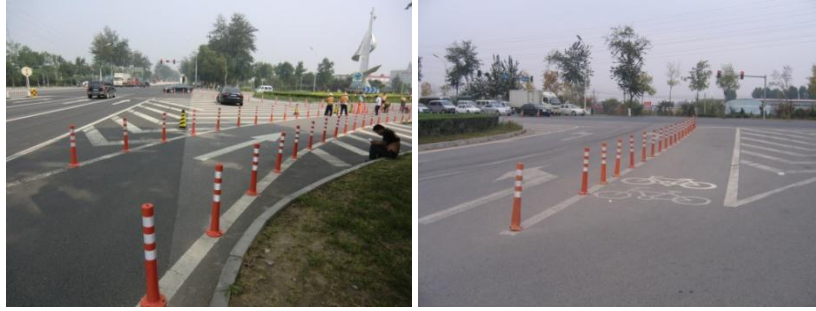
Figure 13 channelization on pavement modified with poles
 Figure 14 poles to separate non-motor vehicles from motor vehicles

The main problems found at the roundabout junction (K28.1) were the motor vehicles and non-motor vehicles were not effectively separated, and some of the motor vehicles drove in opposite direction when bypass the junction.

The countermeasures taken at the roundabout include poles installed to separate non-motor vehicles from motor vehicles; “YIELD” and “STOP” signs and markings are installed; channelization on pavement are modified with the installation of poles as shown of figure 13,14 and 15 below:

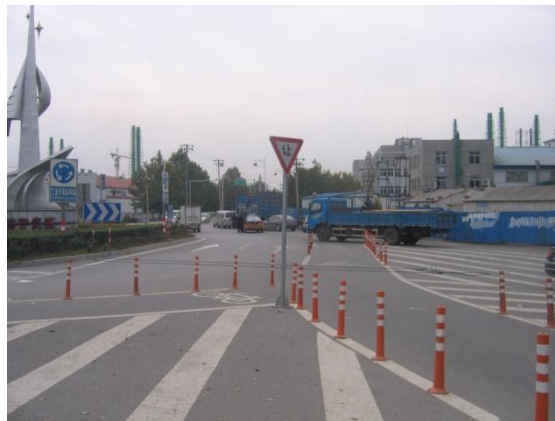
Figure 15 “YIELD” and “STOP” signs and markings installed

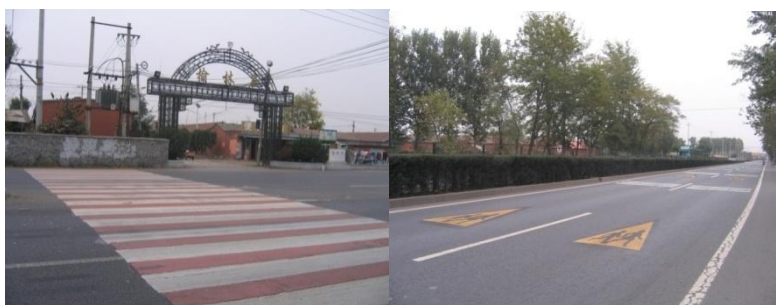
Figure 16 pedestrian crossings with colored anti-skid pavement

Figure 17 pavement figure markings and horizontal speed pavement markings

Since villages nearby, the main problem found at the non-signal controlled pedestrian crossings (Yulinzhuang - K38.5 and Matou - K43) were a) there were many pedestrians crossing the road. Since the junction was non-signal controlled, the high vehicle speed put the pedestrians at risk; b) the lines at pedestrian crossing were poorly maintained – hard to see especially at night.

The countermeasures taken at the two pedestrian crossings include speed reduction markings, colored pavement, graphic signs of pedestrian crossing, color-painting for pedestrian crossing, reflective road studs were used (as shown of figure of 16,17, 18 and 19 below) to make drivers aware of different road environment ahead and to slow down the speed.

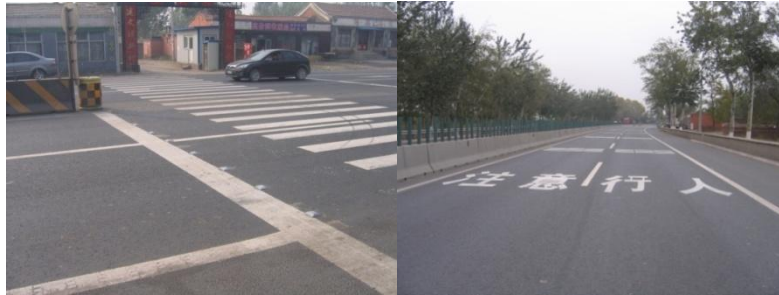
Figure 18 retro reflective road studs

Figure 19 pavement character markings and horizontal speed pavement markings
