Testing the Pedestrian Safety of Bull Bars: Methods and Results

by R.W.G Anderson, AL van den Berg, G Ponte, LD Streeter and AJ McLean,

Centre for Automotive Safety Research, University of Adelaide, South Australia 5005

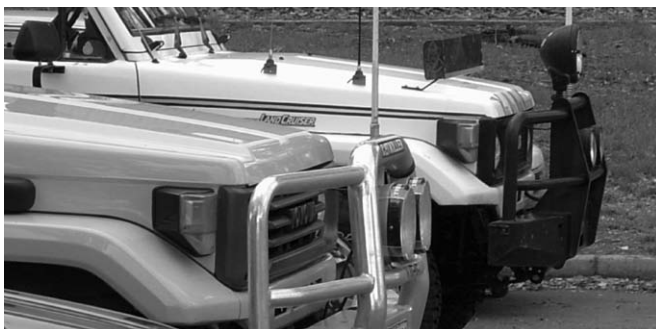
Two methods were used to mount the bull bars for testing. In most cases the bull bar was attached to the corresponding vehicle, according to the manufacturer's instructions. However, in some cases, mounting the bull bar to the vehicle would have required modification to the vehicle chassis rails. As the vehicles were to be (separately) crash tested by ANCAP after these pedestrian impact tests, the modifications could not be made, as the subsequent crash test might have been compromised. Instead, a universal chassis rail rig was used.

The chassis rail rig was checked to ensure that the results of the tests would be a valid representation of the bull bar as it would be on the vehicle: this was checked by testing a bull bar on the rig and again on the vehicle. The results from each test (headform and upper legform) were almost identical (within a few percent) and the standard chassis rails were deemed to be an accurate replacement to a vehicle chassis.

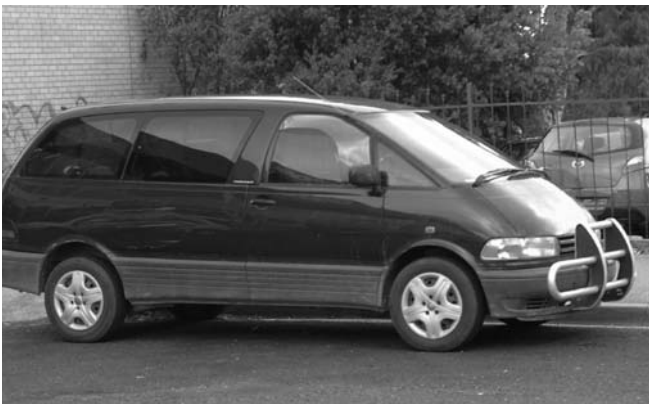
The results of the Part C tests are given in Table 6. The results show that the polymer bull bars produced the least severe headform impacts on average, but were more severe than the results of the tests on the corresponding vehicles in two of the three tests (Patrol and Rodeo). The steel and aluminium/alloy bull bars produced more severe impacts than either the polymer bull bars or the leading edge of the vehicle. In several of the tests of steel bull bars the HIC values listed are artificially low, as the acceleration exceeded the measurement range of the instrumentation. The results of the bull bar tests were significantly associated with the bull bar material (Kruskal-Wallis test, $n = 11$, $P < 0.05$).
