Improving the safety of children who use school buses

Abstract

This paper summarises the results of two research projects on the safety of children that use school buses.

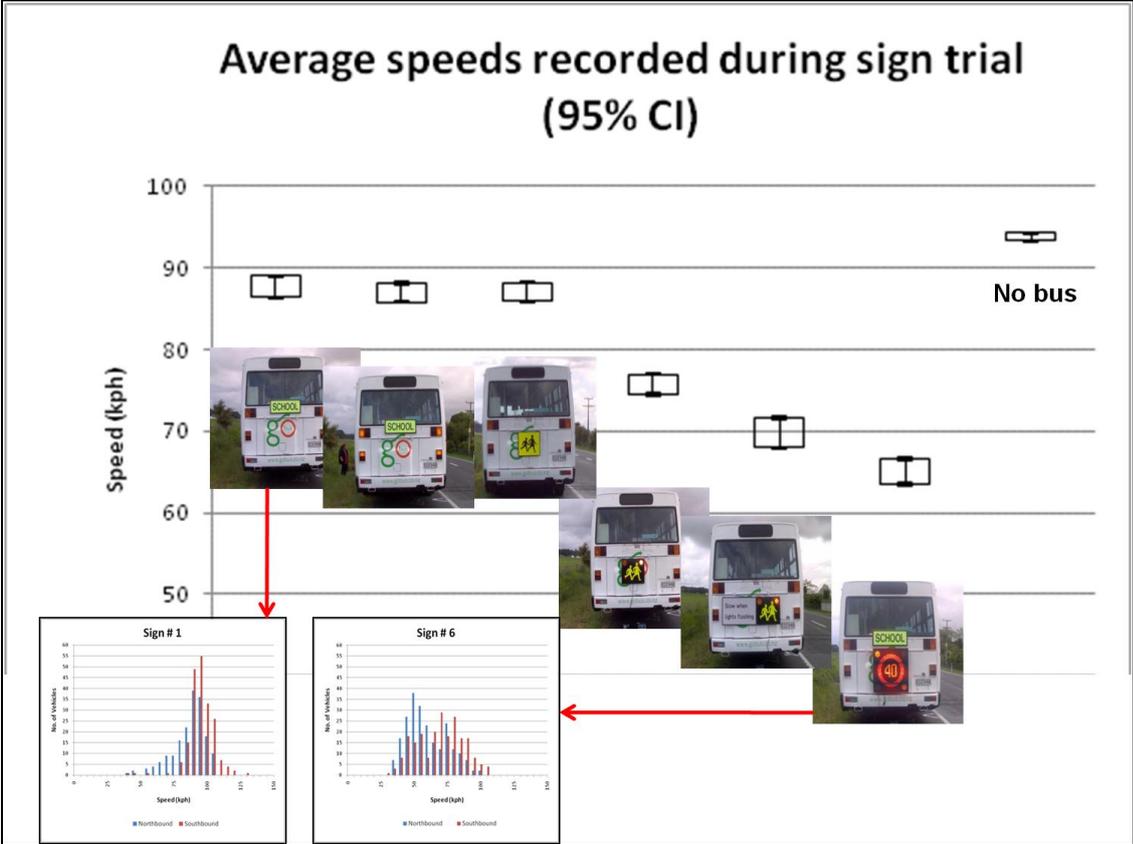
Overall, the active signs had a significant effect on reducing traffic speed (figure 1 and appendix A-1). However there was also significant variation in speeds, which is of some concern as less homogenous speeds have been linked with a lower level of safety.

Figure 1: Sign trial results (see appendix for more information)

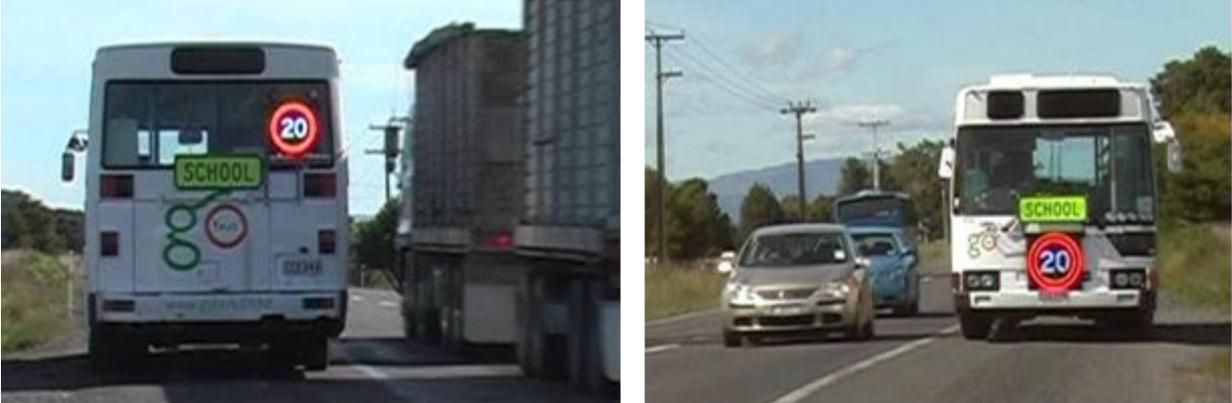
The best performing sign on the rear of the bus in terms of speed reduction was the smaller and more highly placed sign, with illuminated LED roundel, flashing beacons, and accompanying “School” sign (figure 2). A preference for this sign was also shown by the stakeholder perceptions survey. On the front of the bus, the large sign was more effective but may be difficult to fit on many buses because of its size. Subsequent tests evaluated various arrangements of the “20” LED speed limit sign as shown in figure 2.

Figure 2: LED-based sign

- a) An area will be selected for a trial (for example Hawkes Bay)
- b) An awareness campaign will be run in the trial area to raise awareness of the 20km/hr speed limit.
- c) After 2 to 3 months, approximately 50 buses will be fitted with LED-based speed limit signs. Speed and driver behaviour around buses will be monitored when the signs are on. The awareness campaign will continue while the signs are in use for a further 3 months.
- d) Very visible Police speed enforcement will be then be added.

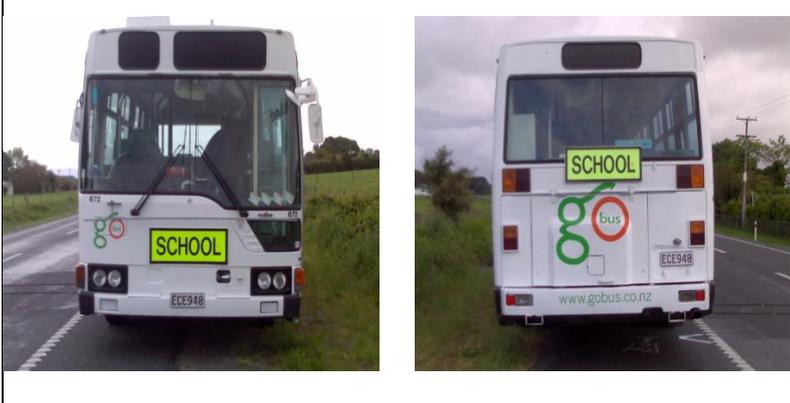
<p>Sign 1. Currently used sign</p>

The image shows two views of a white school bus. On the left is the front view, featuring a green 'go' logo on the left side of the windshield and a yellow rectangular sign with the word 'SCHOOL' in black capital letters centered below the windshield. On the right is the rear view, showing a similar green 'go' logo on the left side of the rear window and a yellow rectangular sign with the word 'SCHOOL' in black capital letters centered above the rear window. The bus has the license plate 'ECE948' and the website 'www.gobus.co.nz' printed on the rear.
<p>Sign 2. Currently used sign with hazard lights</p>

The findings of this research showed that the existing “School” sign had little effect on passing traffic speed, nor did the same sign with the hazard lights on or a static ‘children

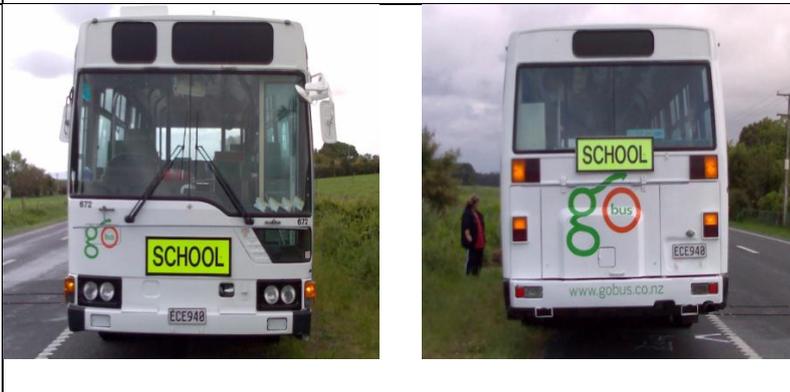
This image is identical to the one for Sign 1, showing the front and rear views of the school bus with the 'SCHOOL' sign. In this version, the bus's hazard lights are illuminated, as indicated by the flashing amber lights on the front and rear.
<p>Sign 3. Children crossing sign</p>

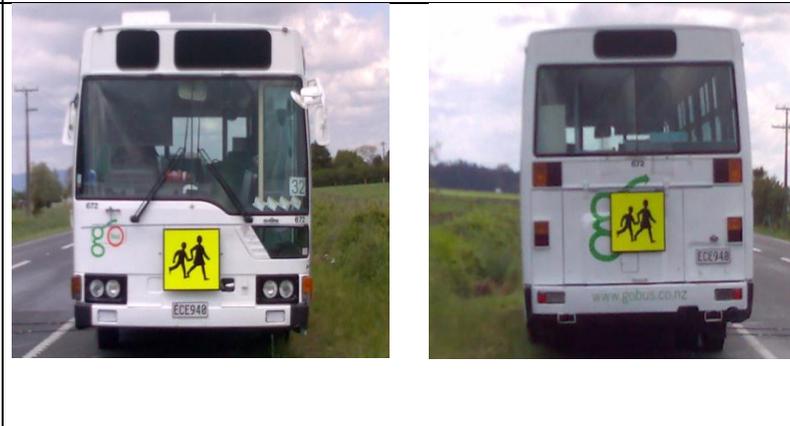
The image shows two views of the same white school bus. On the left is the front view, with a yellow square sign featuring a black silhouette of two children walking across a road, positioned below the windshield. On the right is the rear view, with a similar yellow square sign featuring a black silhouette of two children walking across a road, positioned above the rear window. The bus has the license plate 'ECE948' and the website 'www.gobus.co.nz' printed on the rear.

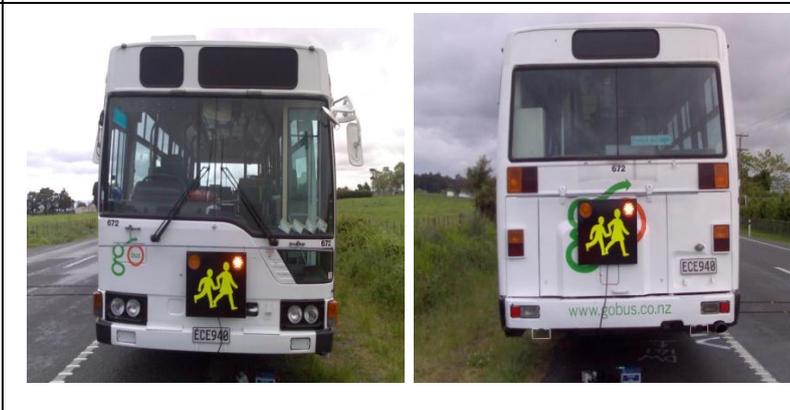
<p>Sign 4. Children crossing sign with beacons</p>

This image is identical to the one for Sign 3, showing the front and rear views of the school bus with the children crossing sign. In this version, the sign is illuminated with red beacons, as shown by the glowing red lights around the sign.

crossing' symbolic sign. A step change downward in speed came when flashing beacons were added to the children crossing symbolic sign and the most effective sign was an existing 40km/hr school zone sign. This sign was associated with a mean speed of 57 km/hr for traffic on the same side as the bus and 67 km/hr for traffic on the opposite side to the bus.

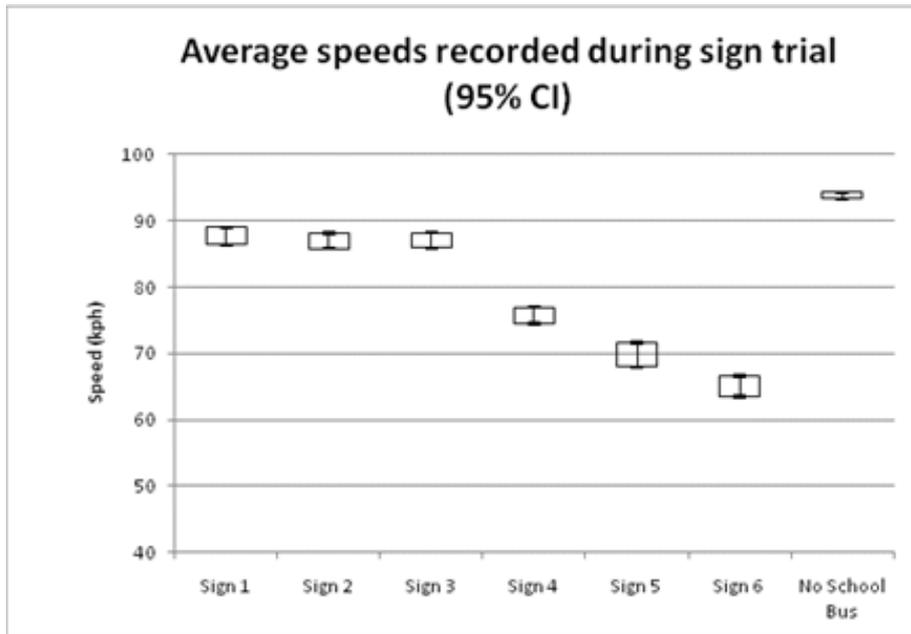
Figure A-1. 95% confidence intervals for mean speed of traffic travelling opposite to the direction of the school bus
