Vehicle Activated Signs: An emerging treatment at high risk rural intersections

Bradshaw^a, C.L., Bui^b, B., & Jurewicz^a, C.

^a ARRB Group, Vermont South, Vic, ^b VicRoads, Kew, Vic

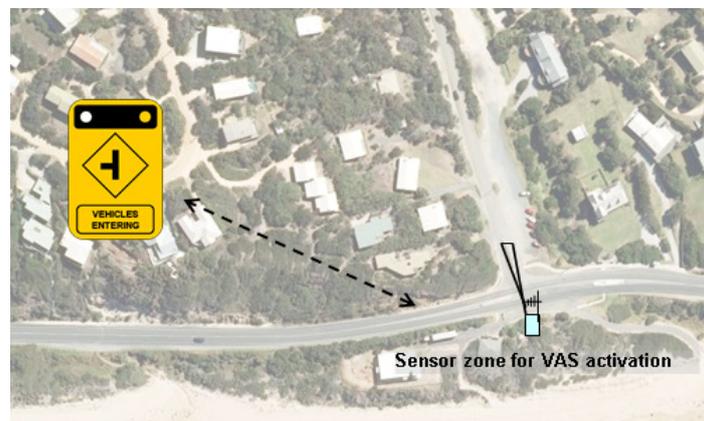
Figure 2. Example of vehicle activated sign arrangement

The VAS lights on the main road approach were activated by a vehicle approaching the intersection on the side road. Vehicles approaching the side road were detected by a camera sensor that identified movement within a specific frame. Camera sensors were placed either opposite the side road intersection or in a corner of the intersection, depending on road features and the ability to obtain an unobstructed view (Figure 2). Note that the site detail shown in Figure 2 is typical of the layout and details for all sites in this study. When an approaching side road vehicle was detected, a wireless signal was sent to a control box mounted on the VAS. As long as a vehicle remained in the sensor zone, the VAS lights remained active. When a vehicle exited the sensor zone, a timing delay was initiated. This delay caused the VAS to flash for a fixed period of seconds after the vehicle exited the sensor zone. The time delay differed by site, according to the road environment (Table 1).

This paper describes the findings of an interim evaluation of the effectiveness of six vehicle activated signs (VAS). The VAS were trialed at selected rural sign-controlled T-intersections with restricted sight distance in south-western Victoria. The VAS were located on highways where an approaching intersection could not be seen easily, due to road curvature. Camera sensors detected side road vehicles approaching the stop line and activated a pair of flashing LED lights on the VAS. The type of VAS used in the present trial is shown in Figures 1 and 2.

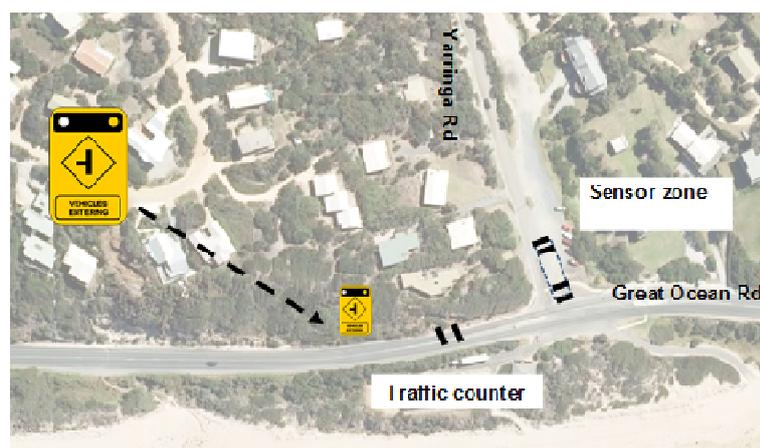
Figure 3. Example of revised data collection set-up at treatment sites

Two sets of tubes on side roads were used to detect the arrival and departure of side road vehicles in the camera sensor zone. One set of tubes was placed upstream of the intersection, to indicate the beginning of a sensor zone. Another set of tubes was placed immediately at the intersection with the main road, to detect when a vehicle exited the sensor zone. Effective sensor zones on side roads were measured on site by monitoring when the VAS activated and deactivated in accordance with the presence of a vehicle in the zone. Main road tubes were placed approximately 30 metres downstream of the VAS. Figure 3 provides a schematic of the final after-treatment data collection method.

At each treatment site, testing of VAS operation was conducted prior to data collection. Tube counters were also tested to ensure that vehicle types and speeds were recorded reliably. Placement of the side-road tubes at the beginning and end of the sensor zones assisted confirmation of the VAS operation timeframes. The times of the main and the side road tube counters were synchronised to enable the research team to identify which drivers on the main road saw the operating VAS and which saw only the inactive VAS.

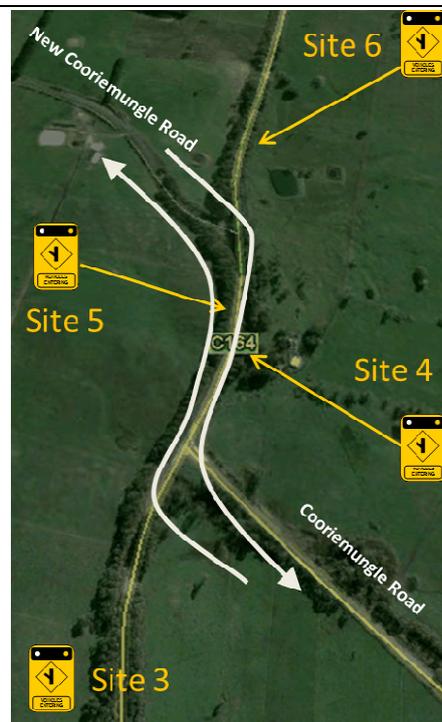
**Figure 5. Cooriemungle VAS sites and the observed side road movements****Key findings from statistical analysis**

The VAS configurations at the Cooriemungle location were different. There were two intersections with both north and south facing VAS, resulting in four VAS sign installations for two intersections in close proximity. The other sites had one VAS per intersection and were not near to any other VAS treatments.

Several potential explanations exist for the increased speeds recorded at sites 4 and 5. Both VAS were preceded by another VAS, as shown in Figure 5. As such, there were four VAS installed to cover two T-intersections that were only 300 metres or so apart. This resulted in a driving experience where there was exposure to two consecutive signs a short distance apart, if the driver continued on the main road past the first intersection. It is possible that a second sign caused the warning effect to decline for the second intersection being approached. Another confounding aspect to this site was that many drivers completed a dog-leg manoeuvre by leaving one side road and entering another. This movement resulted in initially slow-moving traffic from the side roads, followed by acceleration along Cobden–Port Campbell Road past the sites of both midblock VAS. The two midblock VAS sites on Cobden–Port Campbell Road produced inconsistent results, with a mix of increases and decreases in speeds after the installation of the VAS treatment. As such, these VAS did not achieve the expected aim.
