Multi-stage Road Safety Auditing to Maximise Development Impact

Oliver Whalley¹

¹*The World Bank, Sydney, Australia*

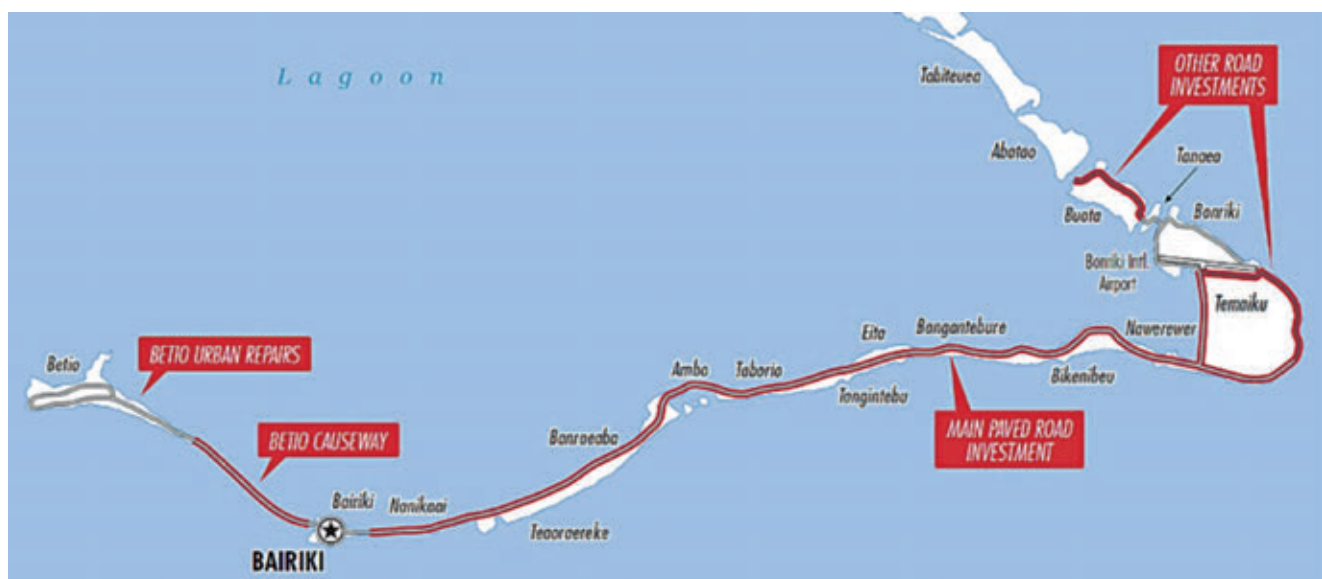
Figure 1. Kiribati location and KRRP road layout (World Bank, 2011)

In South Tarawa, the community is linked by a single main two-lane sealed road and four causeways that run east to west (Figure 1). For the majority of its length, the road passes through ribbon development comprising residences, businesses, schools and hospitals, all located within the confines of the atoll, which is less than three meters above sea level and has an average width of only 450 meters (World Bank, 2011). Virtually the entire population lives close to, and is affected by, the road's condition.

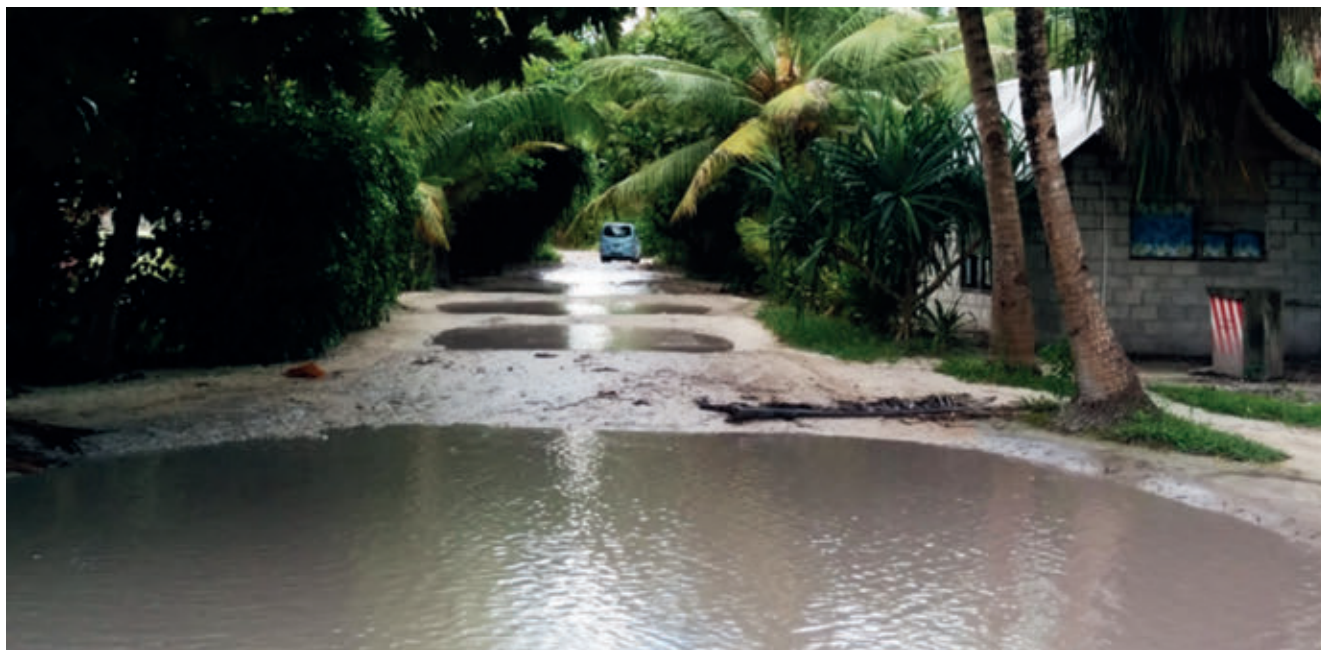
Figure 2. Poor condition of South Tarawa Road prior to the KRRP

result of the pavement condition. While lower speeds were advantageous from a road safety perspective, the driving conditions were hazardous particularly after rain (Figure 2). Further, during the dry season the dust from unpaved sections of the road contributed to widespread upper respiratory problems amongst local residents.

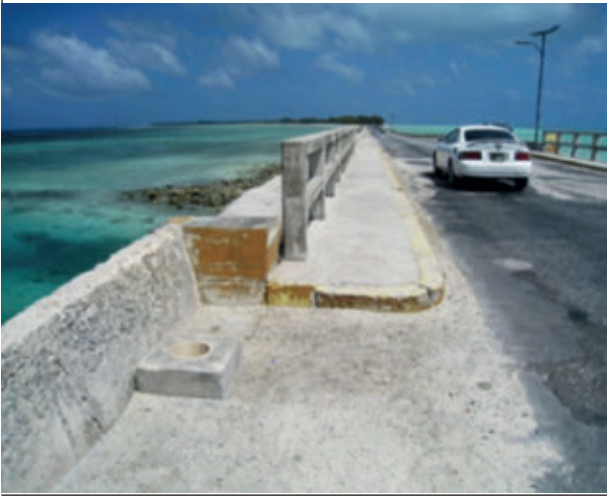
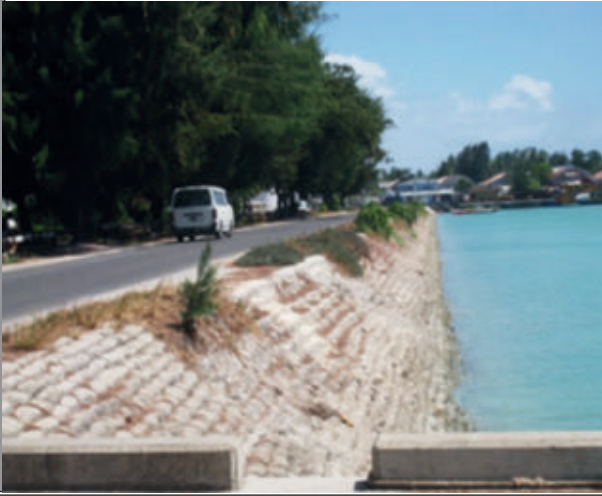
SAFETY CONCERN	RISK	RECOMMENDATION
<p>There are numerous trees and houses, shops and other fixed objects within the clear zone along this road. There are too many to individually highlight, and it is expected that removal of the trees will not be a favoured option. The installation of crash barriers is not recommended – such barriers will not fit in some parts because of inadequate widths for offsets and deflection. They will also cause ‘innocent hits’ when buses/cars pull too close.</p>	<p>High</p>	<ul style="list-style-type: none"> • Design the road with suitable line marking and associated delineation to minimise the risk of a vehicle leaving the road. • Take into account especially the locations at each end of the causeways (where speeds will be highest) and ensure that delineation of the curves is excellent. • At selected locations install 2-3 chevron alignment markers (CAMs) to delineate a sharp curve. • Consider developing a program of tree removal to remove only those trees that are closest to the road in high risk locations (blackspots) at the end of the causeways.

<p>The bridge on the Betio causeway is narrower than the road cross section. The footpath and the bridge railing are road side hazards. The design proposes a cantilevered footpath to serve pedestrians and to maintain the road width.</p>		<p>The Betio port road runs beside the sea – a safety barrier is now proposed to prevent a vehicle from dropping 4m into the sea here.</p>

Figure 3. Example of feasibility RSA findings showing safety concerns and recommendations (Road Safety International, 2010)

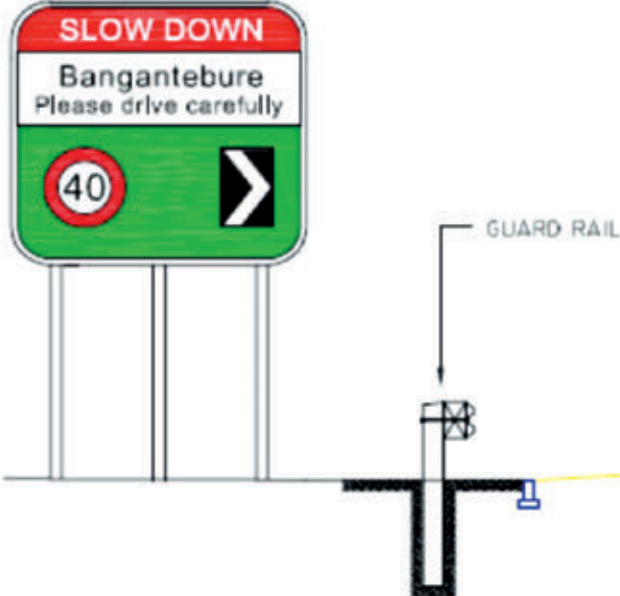
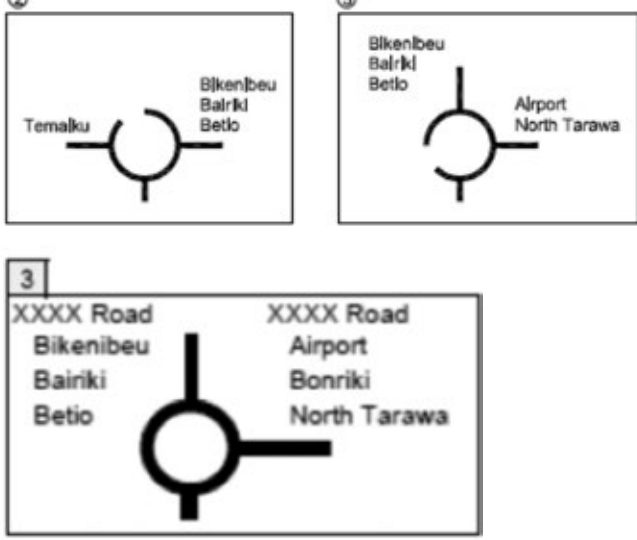
<p>The proposed gateway sign is a good concept but the design is not as useful for safety as it could be. The hazard marker is incorrect and may confuse drivers. The term SLOW DOWN implies people are speeding and yet the speed limit in advance of this sign will be the same as after the sign (40km/h). Drivers should be told why they need to be careful – usually because they are entering an area with more pedestrians than elsewhere.</p>	<p>These signs shown for the roundabout proposed at the T junction of the Airport Road/main Road are incorrect. The “gap” in the circulating carriageway should always be just to the right of the entering road (ie just to the right of the road on the bottom of the sign). Sign No 3 is from Figure 17 in the draft design report. It needs to be reviewed and corrected together with the other diagrammatic directions signs shown there.</p>

Figure 4. Example of detailed design RSA findings (Road Safety International, 2011)

In Phase 2, a RSA was conducted on the draft detailed design of the KRRP civil works. The auditor was the same individual who undertook the feasibility RSA, with an updated issue table prepared to assist the designers with refining the design (Road Safety International, 2011) – Figure 4 for an example on signage. Using the same auditor for feasibility and detailed design stage RSAs resulted in a consistency of input and made use of the relationship that had been established with stakeholders.

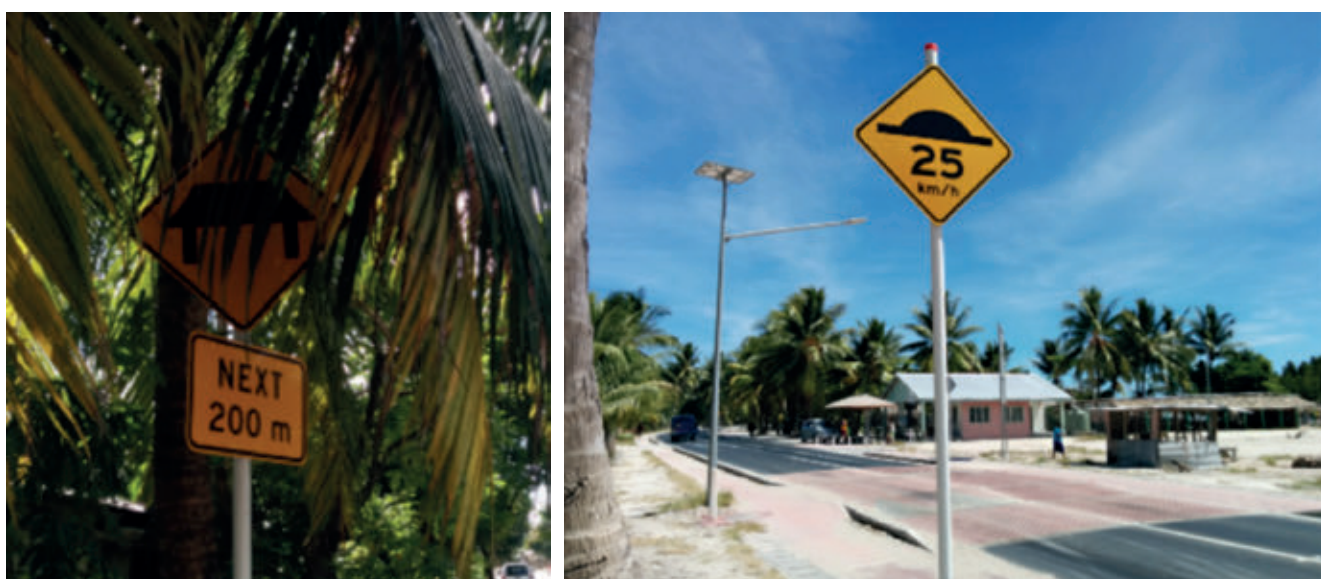
Figure 7. Example of obscured signage (left) and completed road showing safety features including signage, line marking, lighting, speed humps, footpaths and drainage (Whalley, 2017)

In general, the auditor observed the general standard of both design and construction of road safety features to be good (Figure 7). The RSAs at feasibility and detailed design stages had clearly resulted in a very safe design, leaving mostly minor construction issues which were relatively simple to address in line with the recommendations of the post-construction RSA. The road safety features resulted in a much safer design, and if recommendations from the post-construction RSA were actioned, they would lift safety to an even higher level.
