Evaluation of narrow median wire rope barrier installation on Centennial Highway, New Zealand

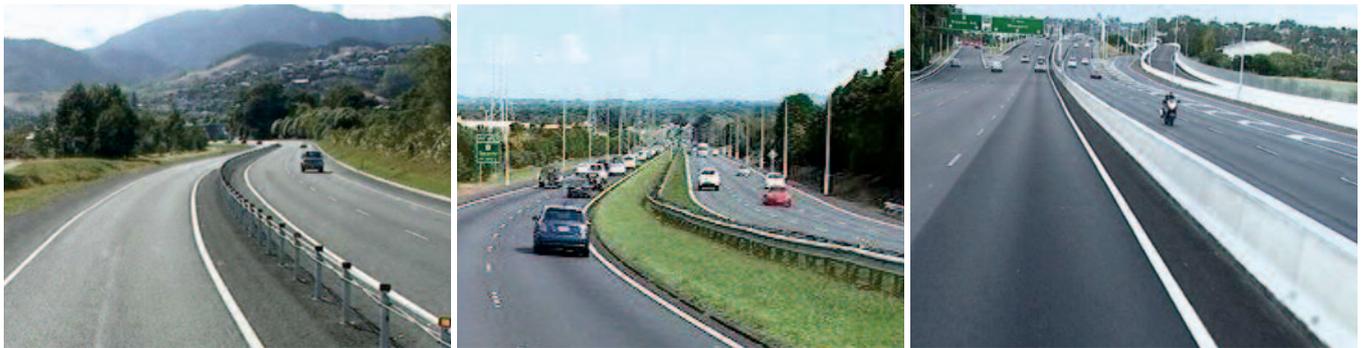
Figure 2. Different median barrier types

Wire rope

Steel w-beam

Concrete

A feasibility study was carried out to investigate the potential use of a wire rope barrier, a semi-rigid steel w-beam barrier and a solid concrete barrier (Figure 2). The solution needed to improve safety while allowing access for emergency vehicles in the event of an incident. If a semi-rigid or solid barrier was installed and a crash caused one lane to be closed, the ability for emergency vehicles to reach the incident would be hampered. In addition, the barrier solution needed to allow flexibility to carry out maintenance activities on the road.

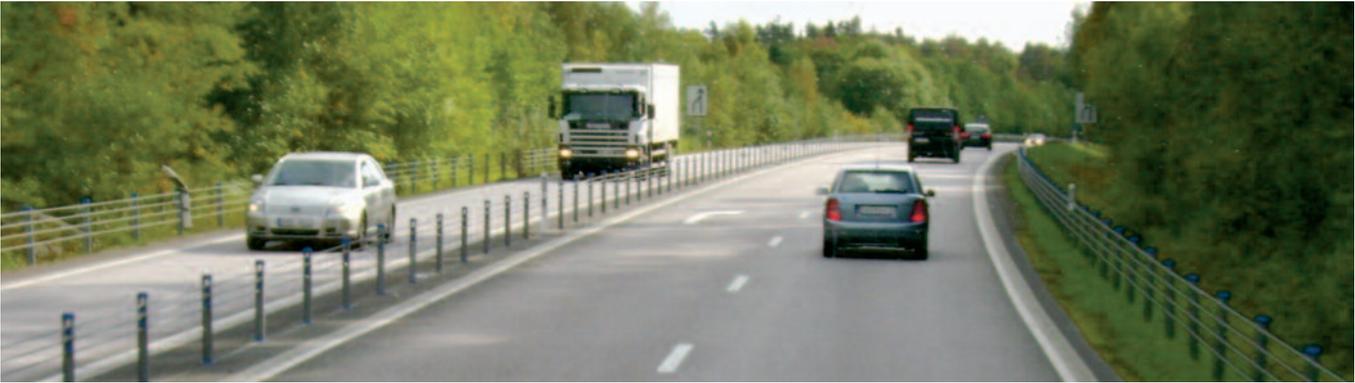
Figure 4. Swedish 2+1 road

Wire rope median barriers are used extensively on Sweden’s ‘collision free’ roads [2]. These roads are generally 2+1 or 2+2 highways and expressways that have been treated with median barriers to separate the opposing traffic directions. The 2+1 roads are three lane roads with two lanes in one direction and one lane in the other, alternating every few kilometres and separated with a median barrier, usually a wire rope barrier (Figure 4). Around 1800 kilometres of collision-free roads have been constructed and opened to traffic as at 1 January 2008.

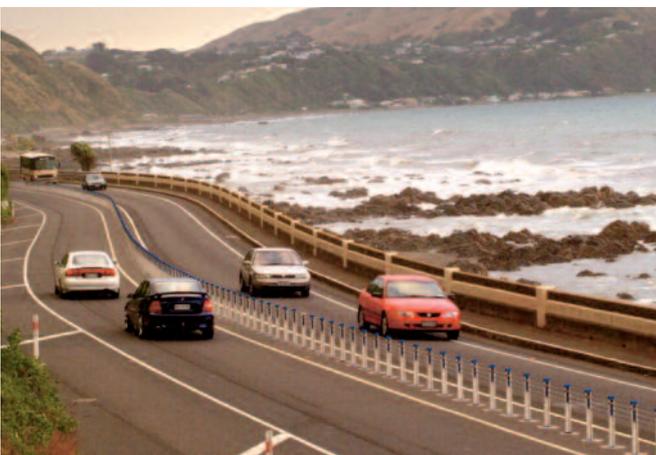
Figure 5. Narrow median wire rope barrier installation on Centennial Highway

Surveillance of the barrier in operation, as described later in this paper, has captured a number of incidents involving a vehicle hitting the wire rope barrier in close proximity to vehicles travelling in the opposing traffic lane. There has been no evidence of problems associated with potential deflection into the opposing lane from crash records or from observations of performance during an impact. Figure 5 shows the final Centennial Highway cross section incorporating a wire rope barrier on a narrow median reserve.

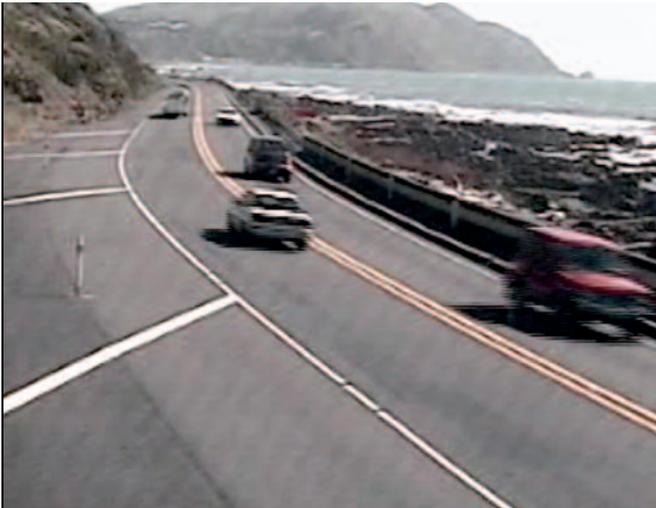
**Figure 6. Lane position before and after installation**

Comparison of footage from before and after the median barrier installation showed that drivers tended to travel more centrally within their lane with the median barrier in place (Figure 6). On the inside of a left hand bend, however, the proportion of drivers tracking to the left of their lane was generally higher, with a small increase in the number of vehicles cutting the left edgeline.

Lane position observations from Camera 3 are summarised in Table 2. An example view from Camera 3 is shown on the left of Figure 6. Vehicles shown on the right side of the double yellow centreline are travelling northbound and vehicles on the left side are travelling southbound.

The southbound results indicated a shift from a distribution skewed slightly to the right of the lane before installation to a distribution skewed slightly to the left of the lane after installation. The northbound results showed a significant shift towards the left, i.e., vehicles tended to cut towards the inside of the left bend. However, this shift may not actually be as pronounced as the results suggest because the majority of vehicles classed as 'Centre' in the 'before installation' scenario were offset slightly to the left. Therefore, any small shift to the left in the 'after installation' scenario would be enough to change the classification from 'Centre' to 'Left' [8].

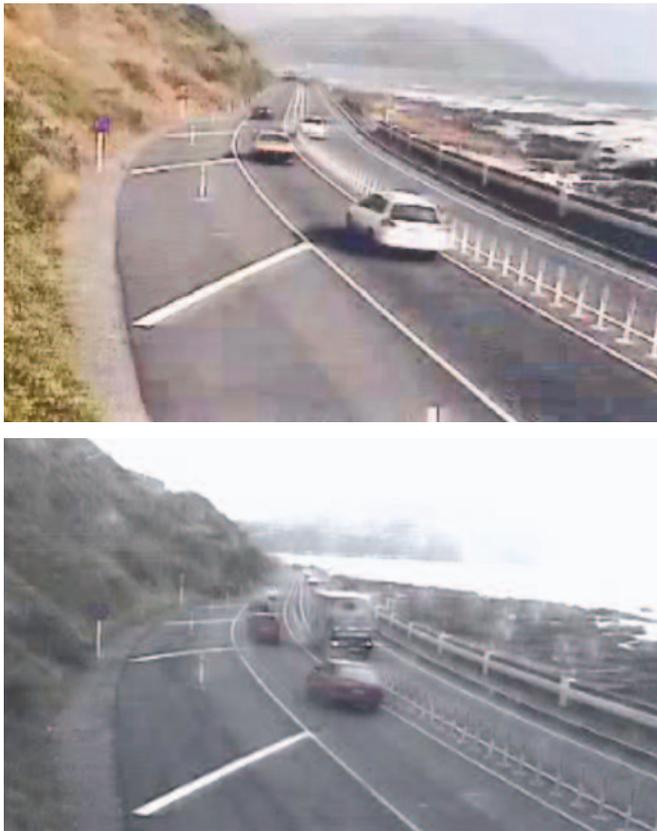
Figure 7. Two separate incidents involving vehicles hitting the median barrier

Generally, vehicles that hit the barrier sustained relatively little damage and were observed to drive away. By way of example, one sunny afternoon a northbound motorist momentarily fell asleep at the wheel and drifted towards the centre of the road. On contact with the barrier the driver awoke and continued the journey without incident. Without the barrier the driver would have veered into oncoming traffic.

A second incident involved a heavy vehicle drifting into the median barrier. Again, without the barrier, the driver would have veered into oncoming traffic. Both of these examples are illustrated by the surveillance footage shown in Figure 7. In summary, the surveillance footage further confirms the improved level of safety along this stretch of highway.
