Planning for motorcycling – A strategy to manage motorcycle risk on the West Coast of New Zealand

Marcus Brown^a, David Scarlet^b, Andrew Crofts^b and Ben Zmijewski^a

^aBeca Ltd, ^bNew Zealand Transport Agency

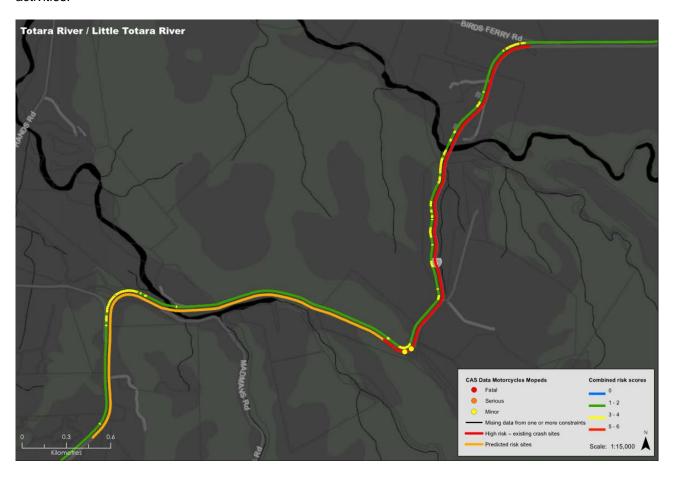
Figure 1. Motorcycle Risk Rating Mapping

A programme of works was prepared which included remedial measures at sites and route sections with deficiencies. This included sites with both a history of crashes, and also at sites designated as having an elevated high potential for future motorcycle crashes based on the risk mapping.

The use of asset management data can be effectively used to supplement crash data and be used to proactively identify sites and routes with a high potential risk of motorcycle crashes. These in turn can be used to develop a programme of sites for further investigation. The resultant risk mapping can be used to inform the overarching motorcycle safety strategy and improvement projects, raise awareness of network risks and influence incremental improvements that can be administered through routine maintenance activities.
