Using the Australian / New Zealand Standard to review barriers for Australian and New Zealand roads

Rod Troutbeck

Queensland University of Technology

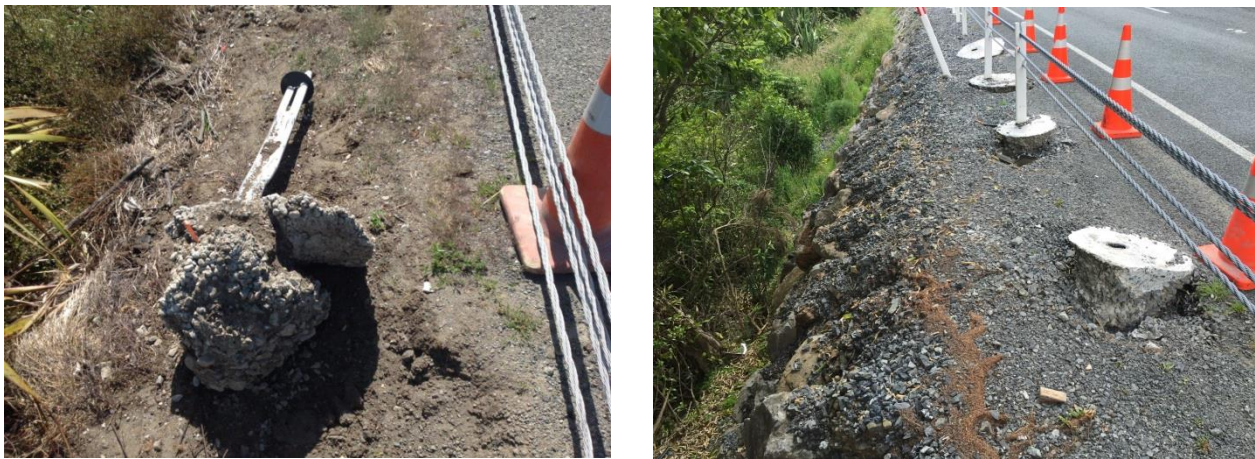
The Technical Advice Note states that inadequate footings are likely to result in a poorer barrier performance, increased chance of injury and increased maintenance costs. The Technical Advice note provides two photographs to illustrate the issue. These comments are not specific to a particular barrier type but rather to wire rope safety barriers as a whole. These are reproduced below.

Figure 1. Post failures shown in NZTA TAN 16-01

Following the comments above, there is a growing concern that adequate designs of post footings are not undertaken. The New Zealand Transport Agency has issued a Technical Advice Note 16-01 in February 2016 on the “Wire Rope Safety Barrier systems – post footing issues”. The advice points out that the footings have failed because the “*installation locations are inappropriate for the*

soil conditions. This may result from a combination of inadequate site investigation during design, poor soil compaction during earthworks operations and/or poor installation practices. Additionally, limited in situ testing of WRSB installations may have masked any installation issues.”

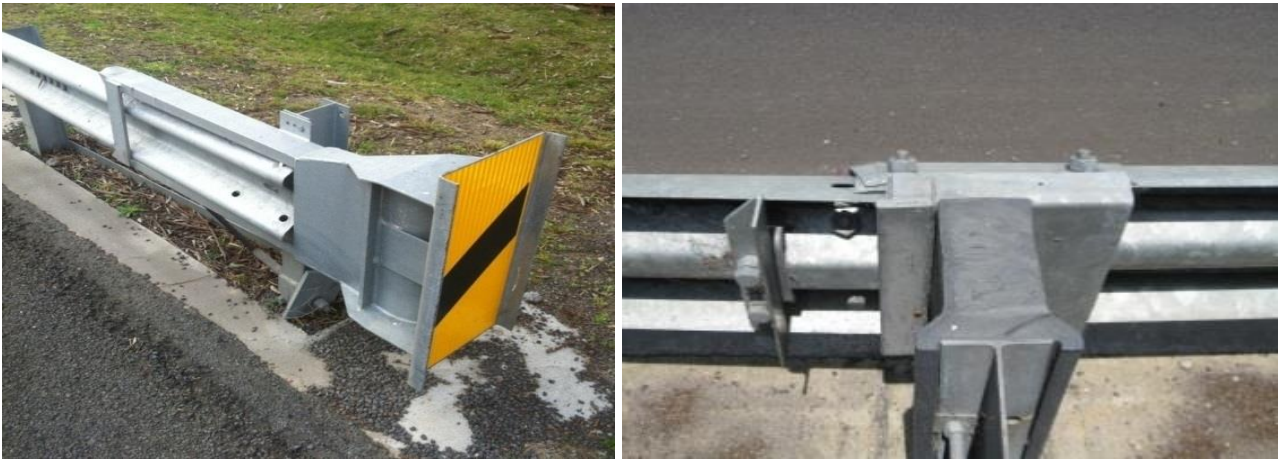
Cassar (2015) has documented a number of examples in which it would appear that the installer was not aware of the correct procedures or to purposely “cut corners” in order to finish the installation quickly. Two examples in Cassar (2015) are shown in Figure 2 in which the details of the design of extruding terminals were not understood and the installation made the terminal ineffective if impacted head on. Cassar has provided examples where posts are not driven to the required depth and the intention is to cut off the posts (Figure 3). These posts will obviously not function as expected.

Figure 2. Incorrect installations from Cassar (2015)

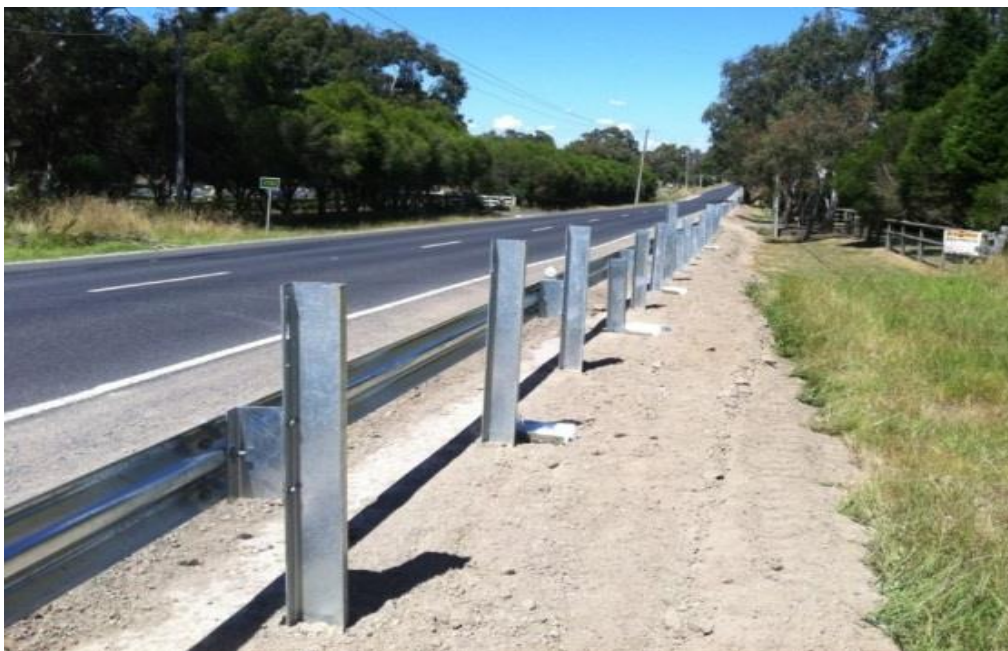
Figure 3. Posts not embedded to the correct depth from Cassar (2015)

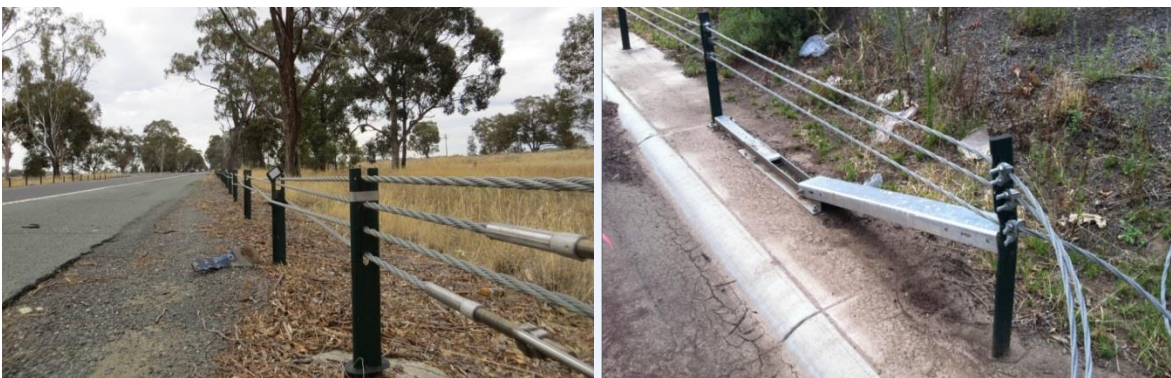
At times an installer will be a little too innovative. Figure 4 shows two examples where an installer has formed a non-standard anchorage and where the barrier system has been repaired using posts from another system (affecting the rope heights and orientation).

Figure 4. Inappropriate wire rope barrier installations from Cassar (2015)
