Painting a different picture of managing speed: the effectiveness of street murals

Living Neighbourhoods and Travel behaviour Section, Road Safety Directorate, Department of Planning Transport and Infrastructure South Australia

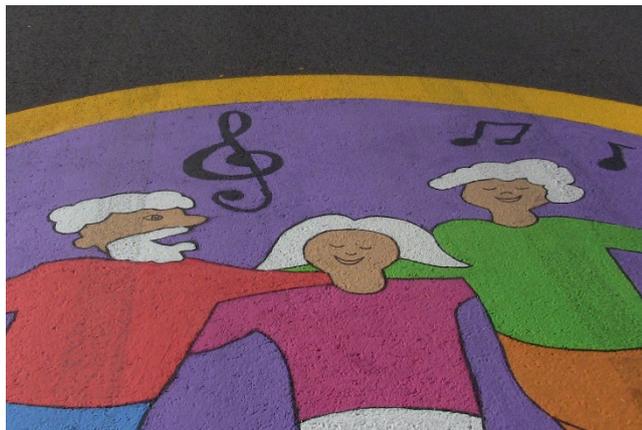
(Image 1: Murals freshly painted - June 2015)

Three years after the installation the condition of the Roopena Street murals has deteriorated (refer to images 1 and 2). The skid resistance was also tested with two small areas not meeting the requirement but identified as low risk.

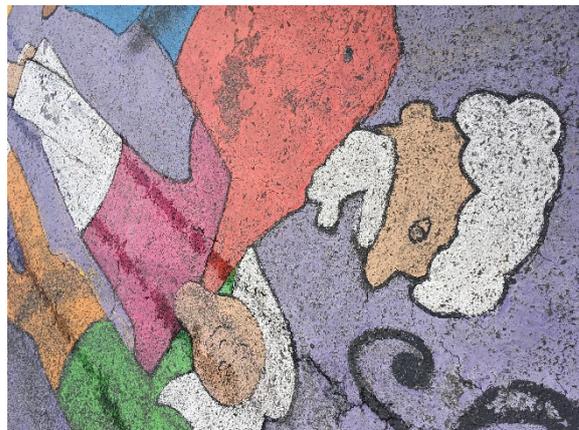
(Image 2: Murals three years on - July 2018)
